NEWBRIDGE TOWN HALL Refurbishment

Main Street, Newbridge, Co. Kildare

CONSERVATION REPORT

de Blacam and Meagher

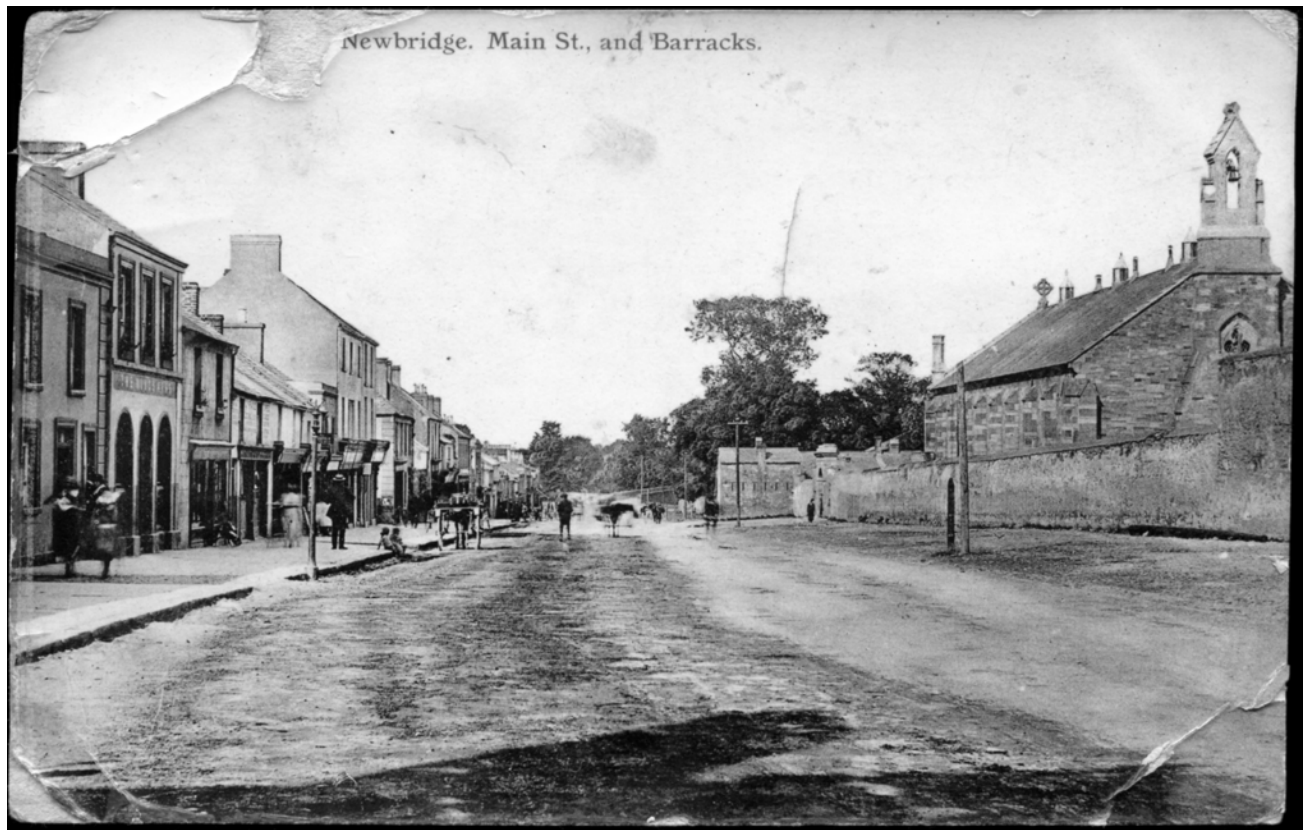
fig 2.1, 1915 Postcard showing the townhall as a Methodist church within the barracks complex. The photograph was taken prior to the removal of the bellcote. The roof vents are in their original condition. Note the celtic cross over the east gable.

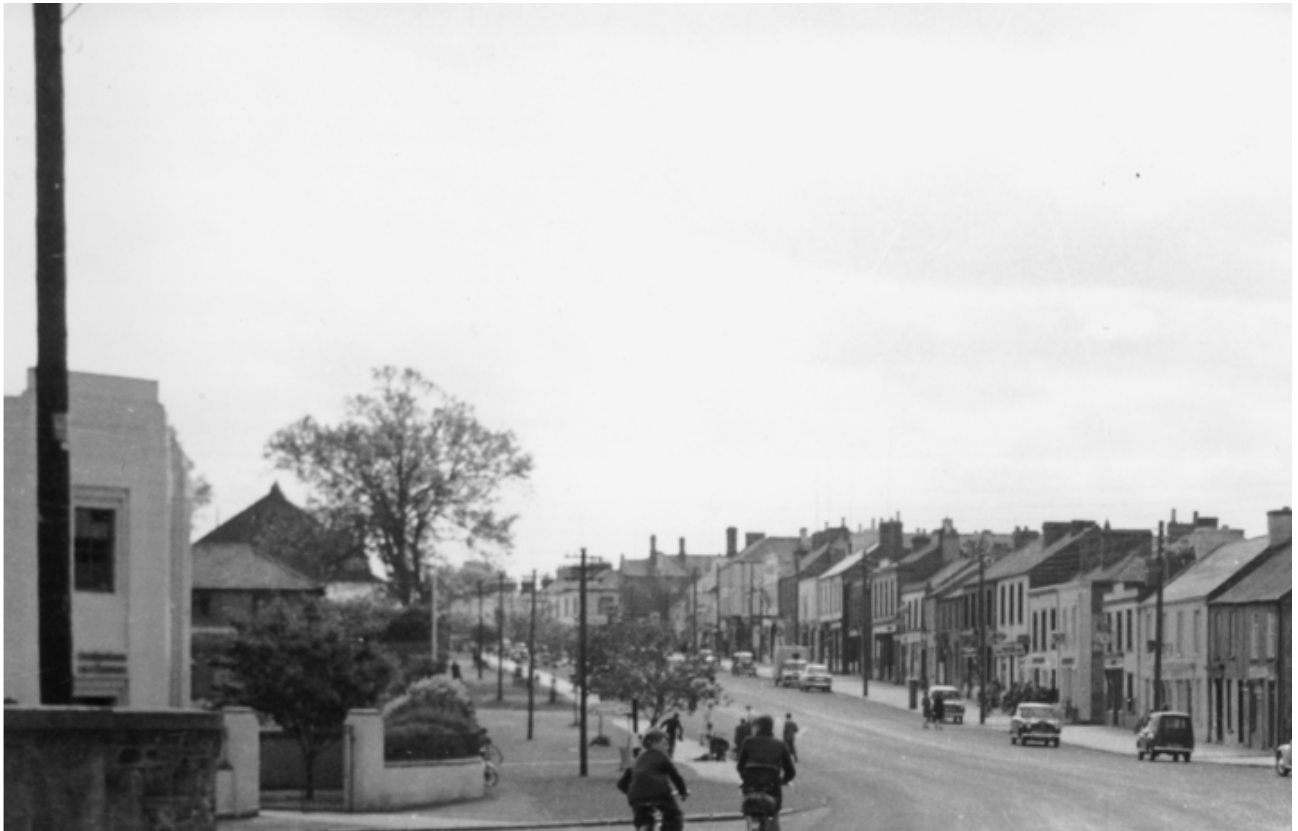
fig 2.2, 1960s photo of Main Street. Note the bellcote had been removed at this stage

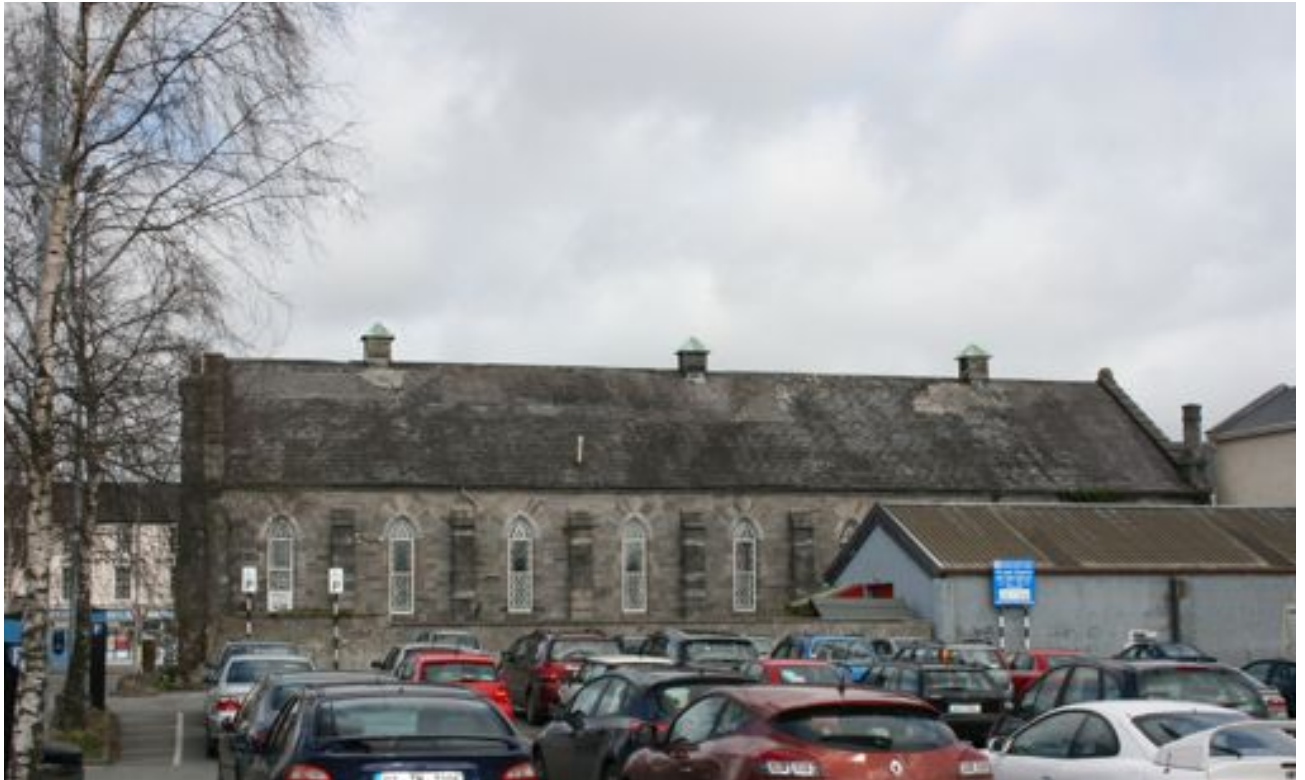
fig 6.1, South Elevation

The **South Elevation** is 9 bays in length with 8 lancet arched windows and a lancet arched doorway at the eastern most bay in the same manner as the north elevation. A shed constructed in the late 20th century has been constructed to the eastern section obscuring the doorway. The door itself has been removed. The windows have been altered in the same manner as the windows on the northern elevation. The first 5 windows from west to east have protective secondary PVC glazing. There are modern blockwork panels (fig 10) to the underside of three windows where the original stonework has been removed. The string course has been broken locally to accommodate a new plastic downpipe. Generally there are areas of stone that have graffiti and paint marks. The stone pointing to the buttresses has failed and there are other areas such as adjacent the downpipes where the pointing is defective. The surrounds of seven windows have been repointed with mastic. The ground level is higher at this side of the building so not all bays have working floor vents. Where they do exist, most have been replaced.

- A Reconstruction of wall below 3 windows on the south facade. Take down the 'modern' block construction below the eil of these windows to the level of the original stone rising wall. Rebuild this portion of wall in limestone to match the equivalent adjacent window in every respect.
Stone - it is understood that replacement stone will be supplied by Kildare County Council from stores in Newbridge.

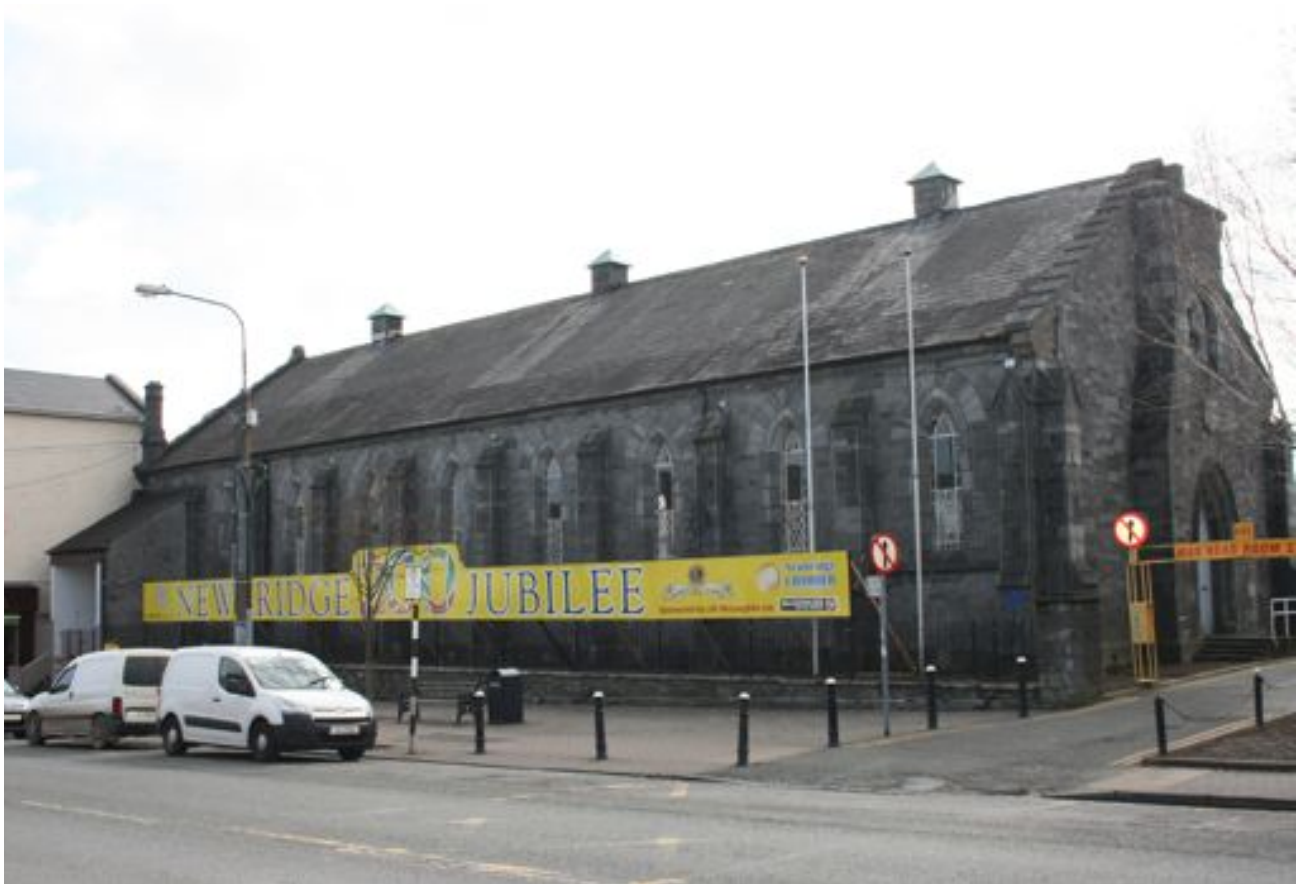
fig 6.2, North Elevation

The **North Elevation** is 9 bays in length with 8 lancet arched windows and a lancet arched door at the eastern most bay. The coursed limestone walls sit on a dressed limestone projecting plinth and are broken at window cill level with a cut limestone string course. The walls are capped with a projecting cut stone coping. The bays are articulated with stepped buttresses. The windows are cast iron in a diamond pattern and are glazed in clear glass. The windows have had their central opening section replaced with a modern clear glass fixed panel. The door in the eastern bay appears to be original and has a molded stone surround. A porch of mid 20th century construction has been added adjoining the door. This includes concrete steps leading to the footpath at street level. The original stone walling at this area has been painted white. There is a vent for ventilating the interior floor structure under each window. Some of the original cast iron vents remain, but most have been replaced with modern steel vents of a different design. The north elevation is fronted with a low wall with modern railings. The low wall is pointed with a cement based mortar. This wall may be the base of what was the original barracks enclosing wall (refer to historic 6 inch map fig 5.2). The stonework is generally in good condition, the pointing appears to be damaged adjacent the downpipes which are leaking.

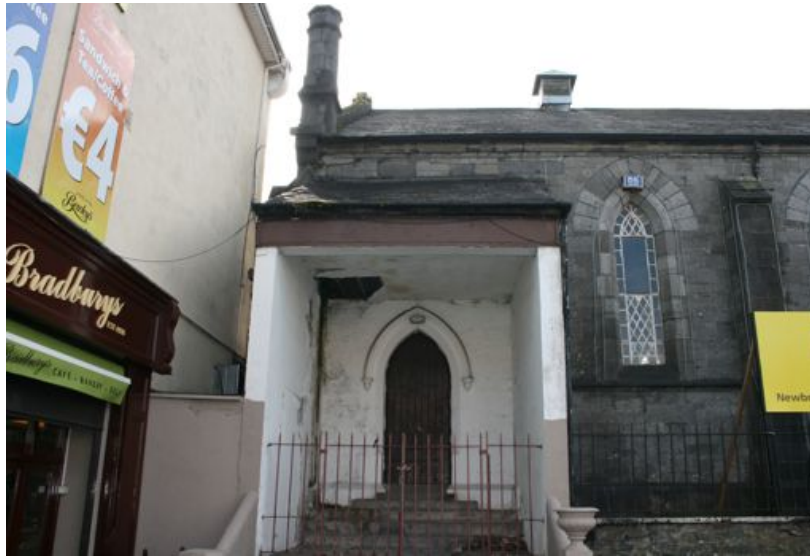
fig 6.5, Porch to east of north elevation

- F Make safe, secure and repair the plant area of the adjoining cafe to the southwest of the church.
- G Take down projecting canopy, side walls and steps including foundations on the northeast corner of the town hall. Make good any damage to adjoining cafe at this location and allow for repainting of adjoining cafe wall. Take down the wall and railings including foundations to the north of the town hall.

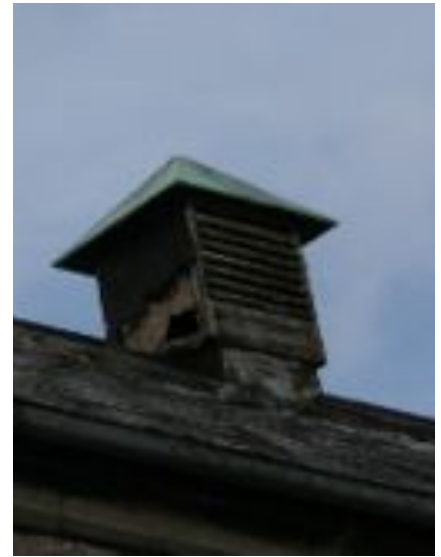
fig 6.6, Roof Vent

The **Roof** of the church is of what appears to be Welsh Penhryn slate laid randomly with clay ridge tiles. There are 3 louvred vents at the apex of the roof. These are of timber construction and have been reclad on two sides with hardboard in the mid 20th century. The copper pyramid roofs of the vents appear to be mid 20th century replacements. The original vent roofs had a different shape and were topped with finials (see fig 2.1). These vents are currently in a poor state of repair. Originally the roof had 3 smaller intermediate roof vents with conical shapes. The roof has been partially covered in a hessian/tar covering. There is evidence that some slates have been replaced with asbestos tiles. The roof is leaking at some points. The existing cast iron rainwater goods are in poor condition and have been partly replaced with plastic on the south elevation.

It is proposed to reroof using like for like materials. The existing vents that have been substantially altered and are in very poor condition are to be replaced.

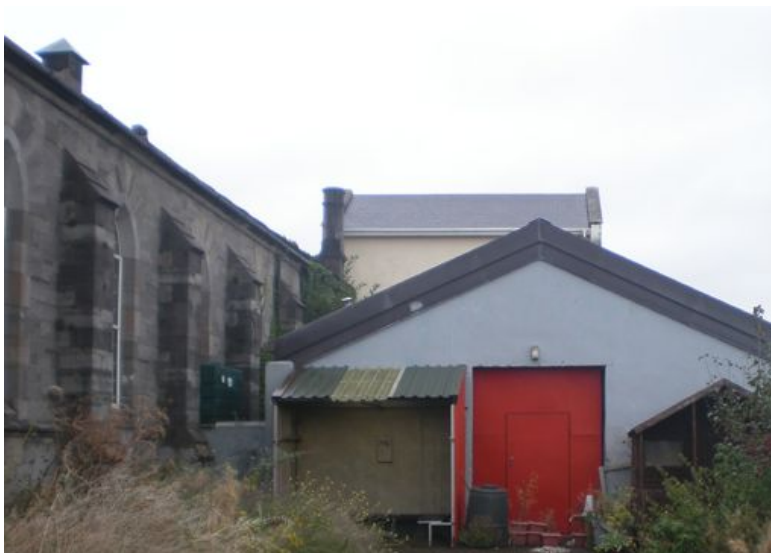
fig 6.9, Existing shed to rear

- D Contractor to carry out a photographic condition survey of all adjoining properties prior to commencement of works.
- E Carefully remove the whole of the metal roofed building and connecting corridor to the southeast including the foundations and drainage pipes

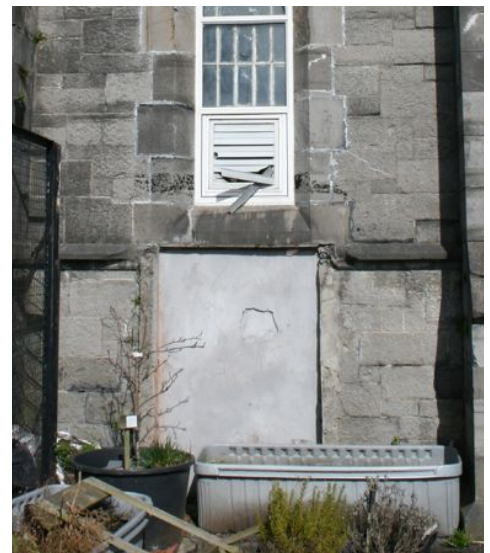
fig 6.10, Window with modern blockwork panel to base

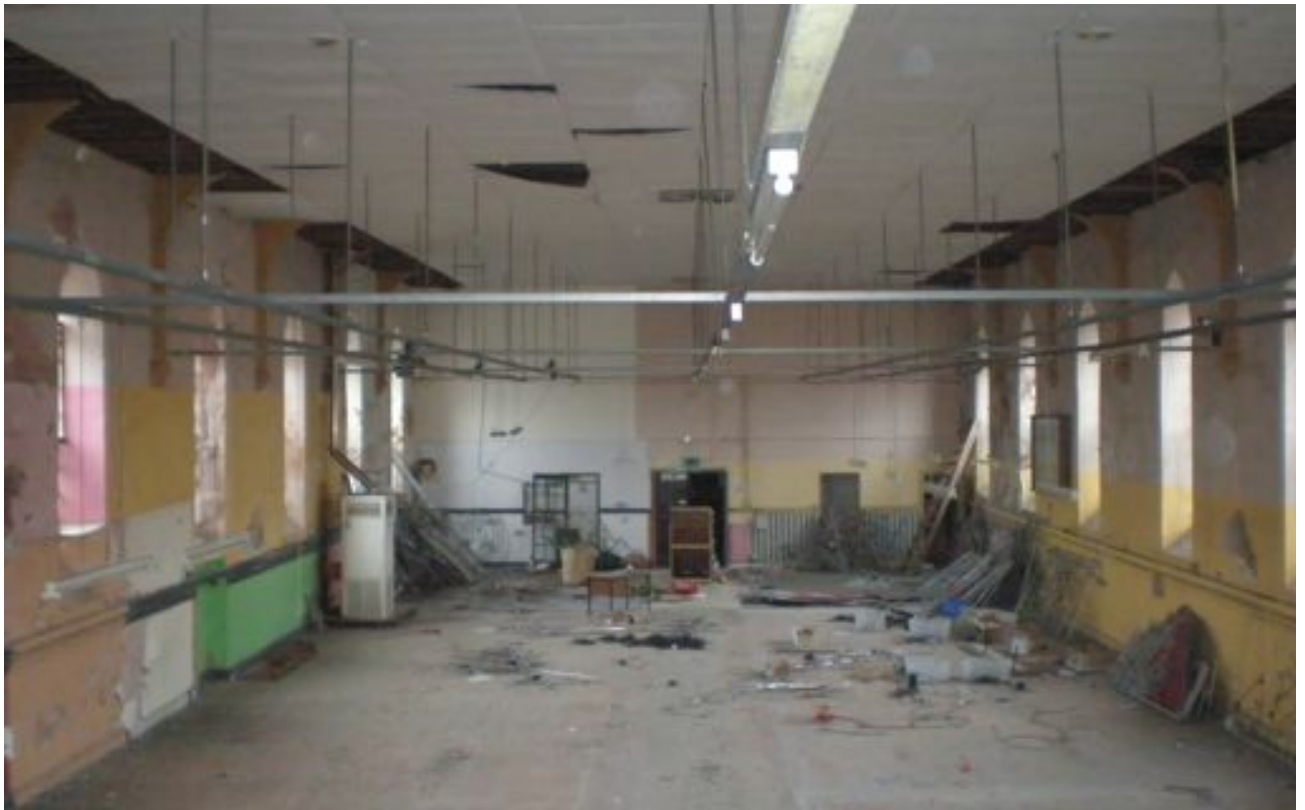
The interior is laid out as a simple hall with minimal interior decoration. The walls are covered in lime plaster with a gypsum skim coat of a later date. There is evidence of dampness in parts, on the western gable, and adjacent where the downpipes are on the exterior. There is a timber dado to the perimeter of the interior. There are modern partitions to the western side of the hall. The floor is of solid maple boarding likely installed in the mid 20th century. The roof structure is exposed internally and is stained pitch pine or similar. The roof is supported with 8 queen posts that rest on pinnacle posts attached to the internal walls. The pinnacle posts have been covered in modern hardboard. The ceiling is in stained tongue and grooved boards. There is some evidence of rot on the wall plate at roof level. To the underside of the trusses are softwood timbers that supported a suspended ceiling that has recently been removed.

fig 6.11, Interior of church - looking west

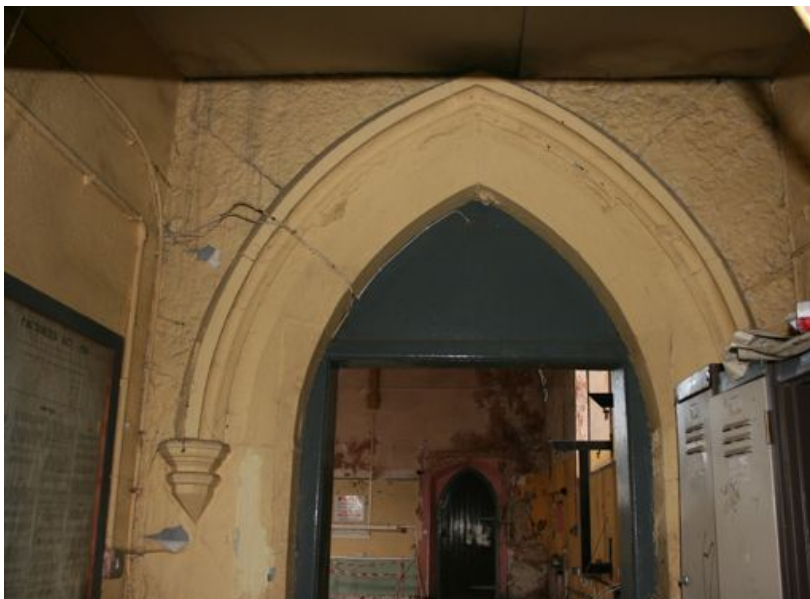
fig 6.15, Exterior of South Doorway (note door is missing)

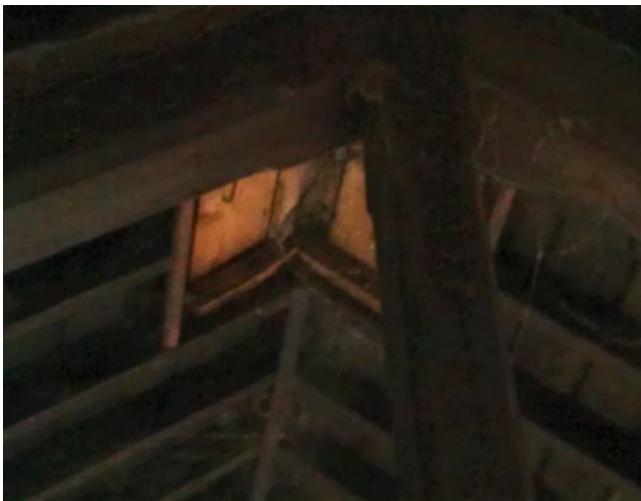
fig 6.19, Trimmed out rafters for vents that have been removed
